ORIGINAL ARTICLE

Bridge Information Modeling (BrIM) used in the operation and maintenance of Civil Engineering Structures (CESs)

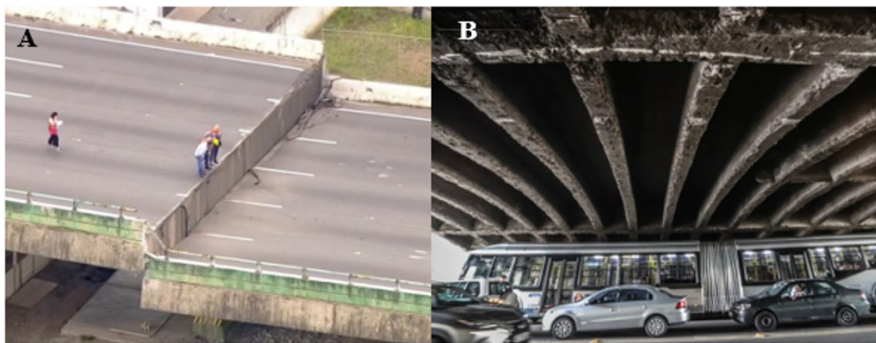
As examples, it is worth mentioning the cases of the Marginal Pinheiros viaduct (Figure 1A), and the General Olímpio da Silveira viaduct (Figure 1B), both located in the city of São Paulo. On November 15, 2018, part of the structure of the Marginal Pinheiros viaduct gave way by approximately two meters. The risk of a major accident was high, given that Marginal Pinheiros is a road with a large flow of vehicles and has an interface with the railroad of the São Paulo Metropolitan Trains Company (CPTM - Companhia Paulista de Trens Metropolitanos), a railway modal used for passenger transportation. The reinforcement of the General Olímpio da Silveira viaduct is exposed under the deck, a frequent problem in CESs in Brazil. Other problems, such as deteriorated expansion joints, beams with damage caused by vehicle collisions, and wear of the support devices between the precast elements, are also common due to the lack of monitoring and maintenance processes.

Figure 1. Pathologies in CESs **A.** Viaduct at Marginal Pinheiros **B.** General Olímpio da Silveira viaduct

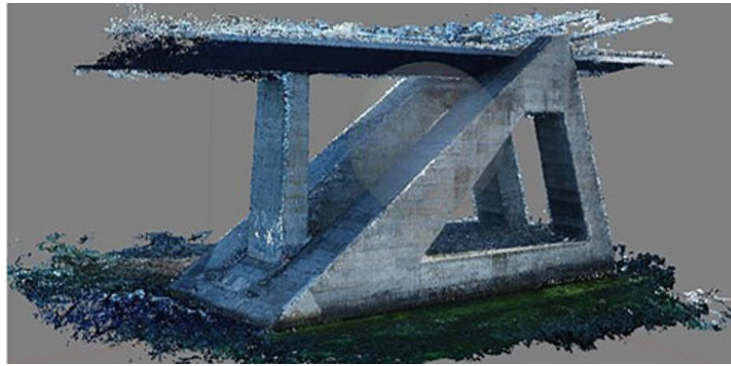
Anomaly detection can be conducted from a 3D model imported along with the imagery as presented by Jensen [19] in Figure 3, or by applying using the imagery from photogrammetry (Morgenthal et al. [14]), shown in Figure 4.

Figure 3. Image overlapping on the 3D model

According to Jensen [19], COWI, an international consulting group specializing in engineering, environmental science, and economics, has developed a web-based tool called COWI Virtual Inspection (CVI). With this tool, the 3D surface model of the structure is imported along with images, both generated from the inspection conducted by the drone, and all the data collected during the inspection is inserted into its respective geographical location. In addition, the data obtained in the field can be recorded in the system. Morgenthal et al. [14] proposed an image processing sequence such as enhancement, segmentation, and feature extraction to identify and group the crack pixels in images. In the future, additional data such as thermography may assist detections.

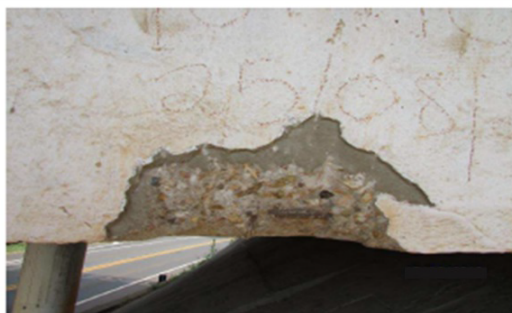
To exemplify the methodology used in the inspections conducted by the Concessionaire, Figure 7 shows an example of a Routine Inspection Form. This inspection was conducted by a specialized company engaged by the Concessionaire, and the procedure adopted for the assessment was the on-site inspection, without the use of special equipment and/or resources, as the viaduct is easily accessible throughout the structure. The pathology assessment was conducted during the inspection, including photographic record for further analysis.

a) Longitudinal beam 3, on overhang 3, with crumbling concrete and exposed reinforcement

Figure 7. Routine Inspection Form

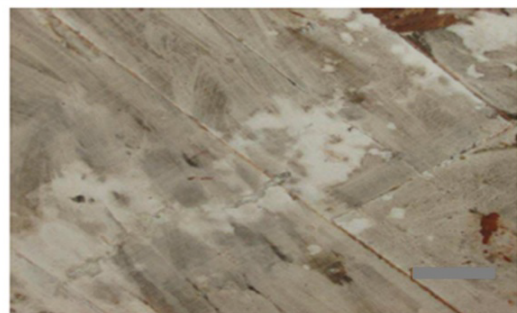
b) Deck slab with crack showing efflorescence

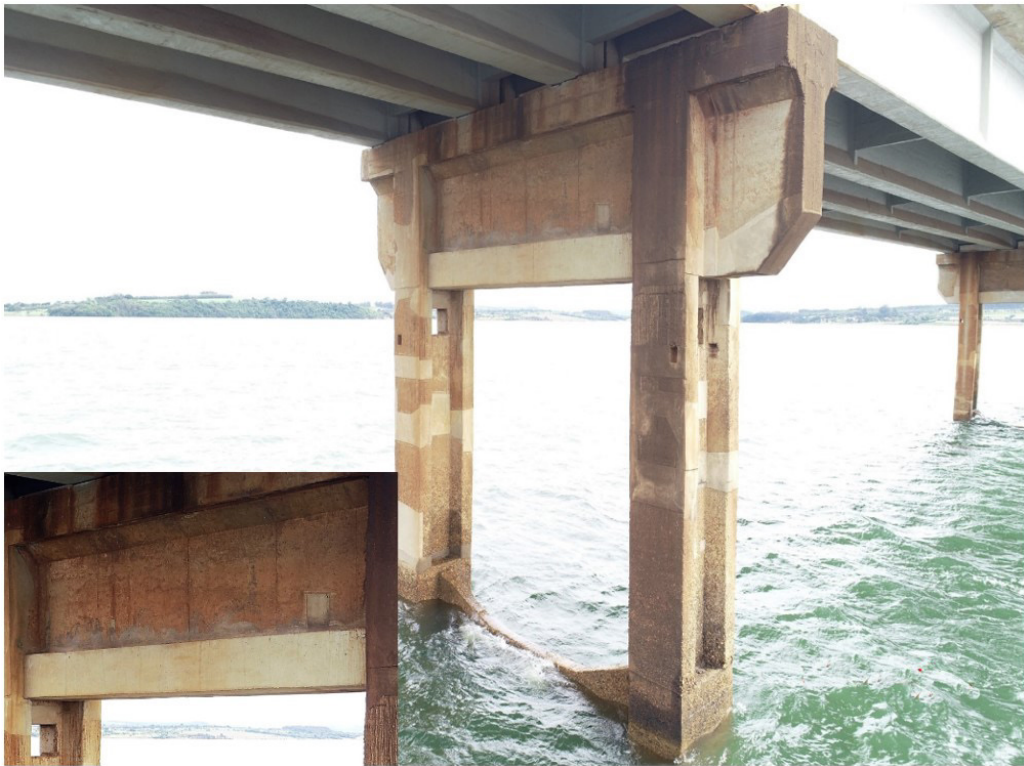
An advance adopted in the most recent inspections is the use of drones to perform inspections in very high and long bridges still in operation, difficulty of access and posing risks to inspectors. This occurs because, to perform such inspections, it is necessary to install temporary structures and/or specific equipment, such as articulated lifting platforms, scaffolding, rope climbing, etc., to allow inspectors to access all elements of the structure. Also, because it is a work at height, specific training and protective equipment for inspectors is required. Figures 8, 9 and 10 are examples of photographic records of routine inspections performed with this tool.

Figure 8. Crossbeam 11 with cracks

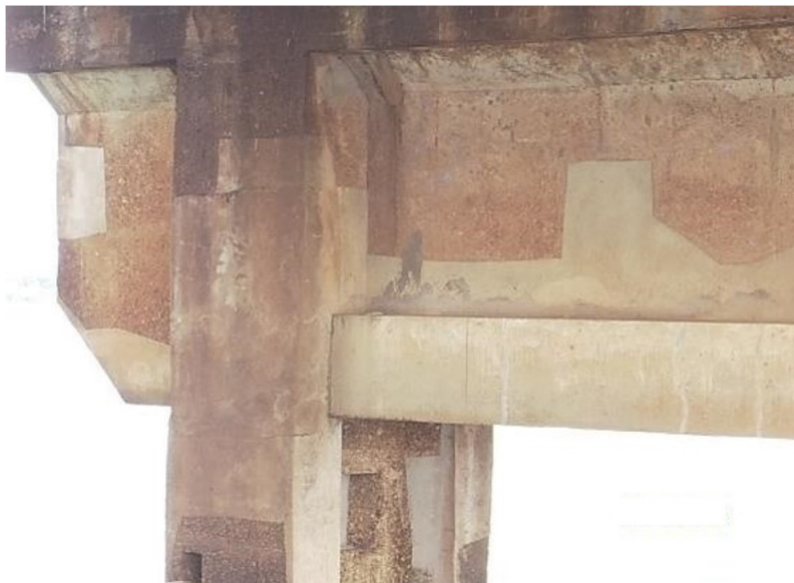
Figure 9. Pillar of support 21 with cracks on the repair.

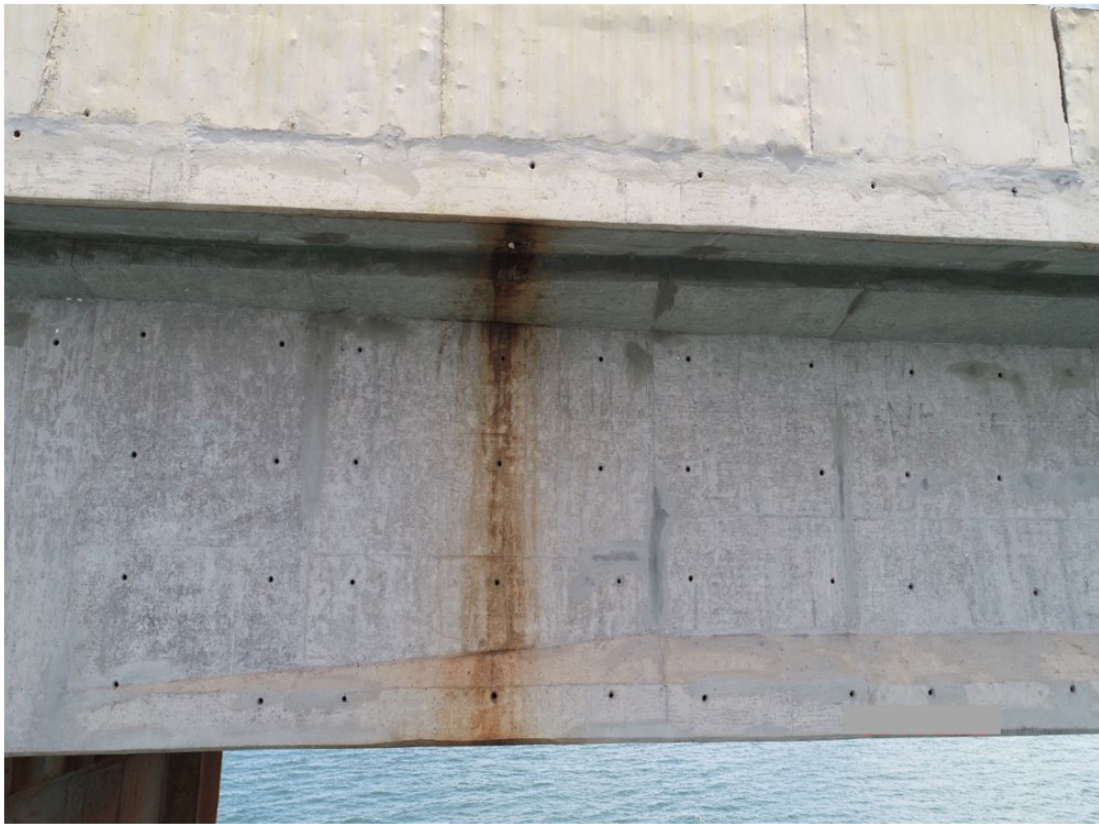
Figure 10. Span 12 of the longitudinal beam 2, with signs of water infiltration. It was possible to note the absence of an extension tube on the drainpipe.

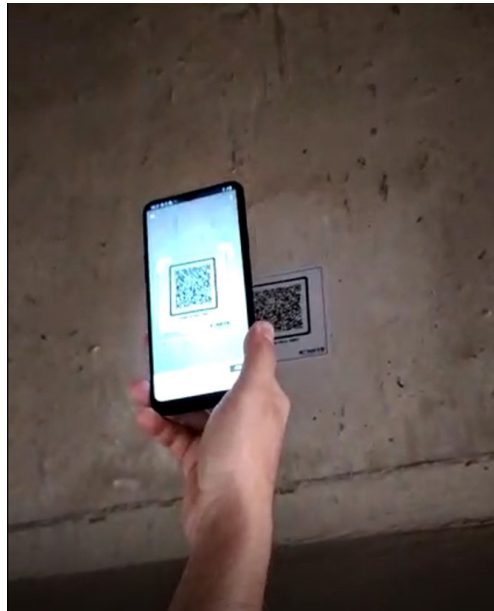
More recently, a new tool was implemented in the CESs, with the objective of allowing access to the data of each one of them registered in the aforementioned system, by reading a QR Code fixed on the structure, with the help of a mobile device (cell phone or tablet).

By reading the QR Code, professionals can access in loco all the information of the structure, included in the system, such as data from previous inspections, with no need to print these reports previously, reducing the use of paper. Figure 11 illustrates the reading of the QR Code implemented in one of the CESs with the use of a cell phone. It is noteworthy that the installation location of the QR Code has been standardized, usually at the lower and inside part the structures, to facilitate access by inspectors and also to prevent vandalism.

Figure 11. Access to the system and CES information using QR Code.
