# Experimental study of the influence of different types of surface treatments on the local repair of columns by jacketing

Adriely Henriques Miranda<sup>a</sup> Leandro Lopes da Silva<sup>a</sup> Élvio Mosci Piancastelli<sup>a</sup> <sup>a</sup>Universidade Federal de Minas Gerais – UFMG, Programa de Pós-graduação em Engenharia de Estruturas – PROPEEs, Belo Horizonte, MG, Brasil

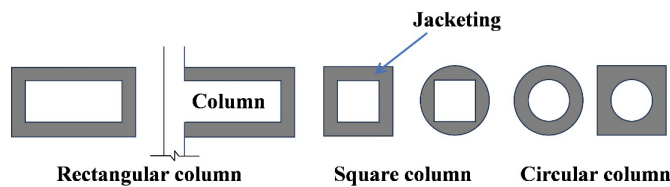
Figure 1. Geometry of columns and jacketing

Repair can occur through various techniques. A technique widely used today is concrete jacketing due to its relative lower cost and simplicity of execution. This technique consists of increasing the cross-section of the column, as shown in Figure 1, through total or partial involvement with concrete, usually, with reinforcement. To reduce the thickness of the jacket, Reis [2] and Enami [3] suggest the use of high-performance concrete. It should be noted that the jacketing can occur along the entire length of the column or only in portion of the column whose resistant capacity is compromised.

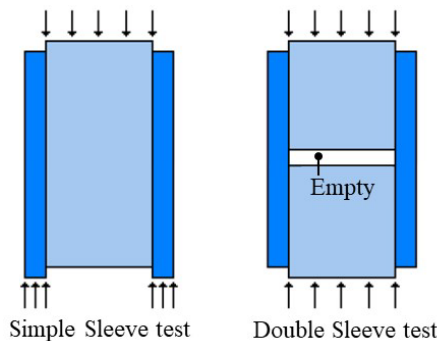
Figure 2. Input and output load on specimens in sleeve test

Piancastelli [1] proposes the use of the sleeve test to characterize the connection between concretes. In the specimens of this test, the load is transferred from one concrete to the other as shown in Figure 2. In this test, it is possible to quantify adhesion and friction.

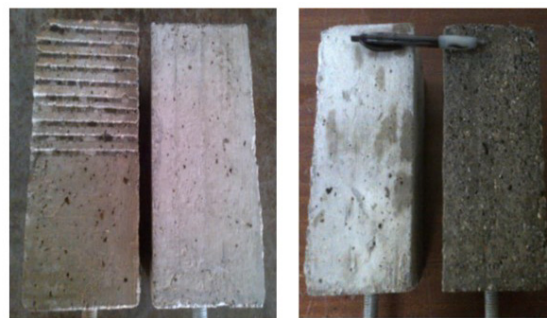
(a) Grooved and Smooth (b) Smooth and Wire-brushed

**Figure 3.** Comparison of substrate surfaces (Chilwesa et al. [8])

Chilwesa et al. [8] sought to evaluate the connection between concretes by varying the types of substrate concrete surfaces, considering smooth, wire-brushed (with a steel brush) and grooved surfaces, as illustrated in Figure 3.

The authors observed that substrate surface roughness is an important parameter affecting interface bond strength, observing an increase in bond strength with an increase in substrate surface roughness, with the biggest increase in bond strength recorded for changes in roughness from smooth (as-cast specimens) to rough (brushed specimens) as compared with changes in roughness from rough (brushed specimens) to very rough (grooved specimens). According to the authors, this suggests that there might be an optimum roughness index beyond which no substantial changes in bond strength can be obtained.

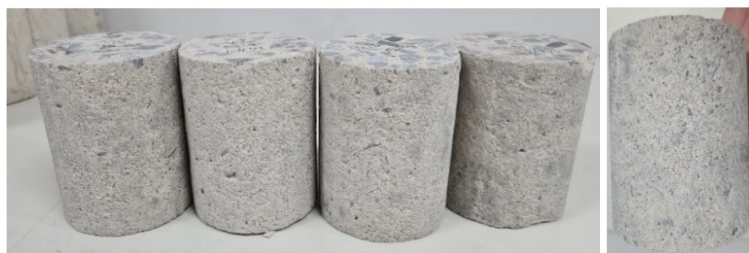
Figure 5. Sanding surface treatment

The sanding of the surface of the old concrete specimens was carried out with a steel brush. The Figure 5 allows viewing the surface of these specimens.

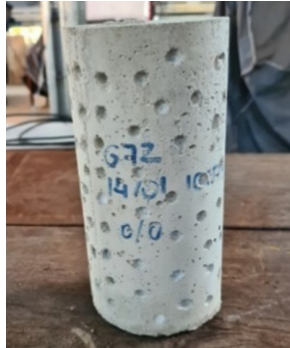
Figure 6. Mechanical chipping surface treatment (holes with drill)

The surface treatment of the mechanical chipping type considered here was performed through holes in the lateral surface of the old concrete specimens, carried out with the aid of a drill with drill bit for concrete with 6.25mm diameter. Aiming to standardize the surface achieved after applying this treatment, it was established that the spacing between

holes would be around 2cm and the hole depth of approximately 5mm. The Figure 6 illustrates the surface of the specimens after this treatment.

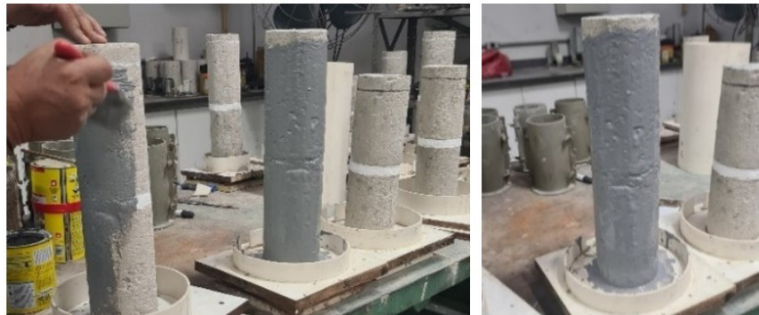
Figure 7. Epoxy adhesive surface treatment

The epoxy resin-based structural adhesive was formulated for bonding concrete surfaces and other materials, providing high adhesion, high strength, impermeability, and fast hardening. In this research, Tecbond TIX Quartzolit was used, which has 60 minutes of open time at 25°C and compressive strength of 40MPa in 24 hours and 50MPa in 7 days. Prior to the application of the epoxy adhesive, the lateral surface of the specimen was sanded. The Figure 7 illustrates the epoxy adhesive application process, in a layer of approximately 2mm.

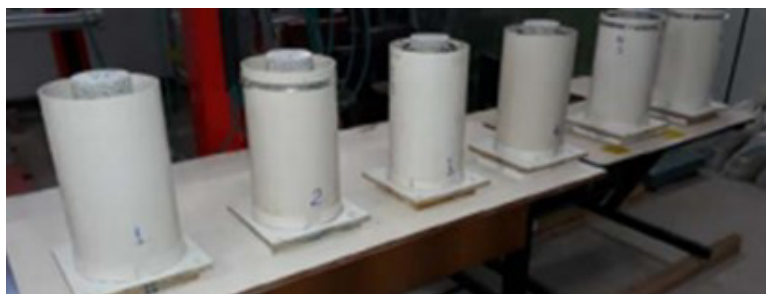
Figure 8. Molds of the sleeve test specimens

Using the molds handmade by Piancastelli [1], in PVC tubes with MDF base, as shown in Figure 8, the jacket was made in new concrete (grout), as shown in Figure 9, by gloving a pair of piled up of old concrete specimens separated by a 2cm polystyrene layer (see Figure 10 in Section 4).

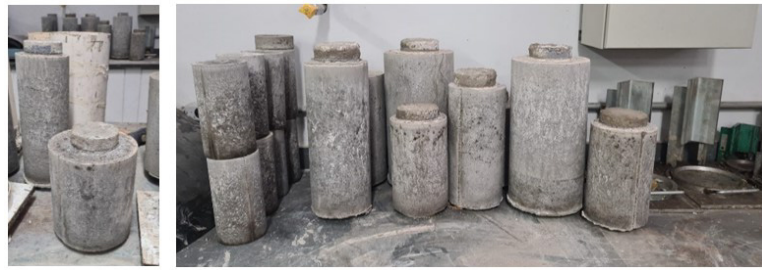
Figure 9. Sleeve test specimens with new concrete jacket (grout)

After preparation, the grout was added to the mold until reaching the mark for the established jacket height.

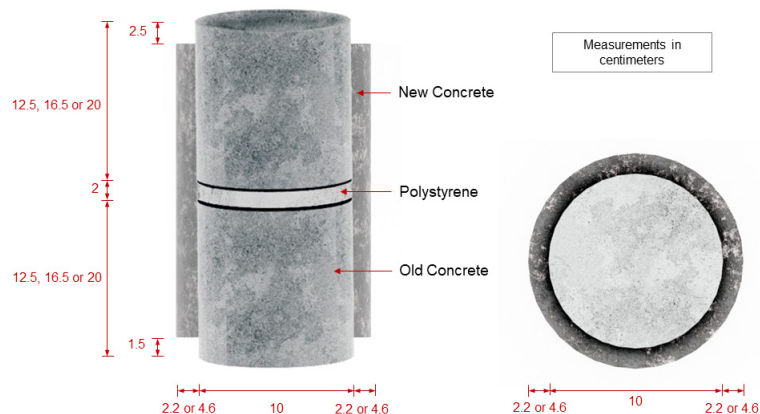
Figure 10. Characteristics of the sleeve test specimens

The jackets of the specimens to be tested were 2.2cm or 4.6cm thick, leading to an external diameter of the sleeve test specimens of 14.4cm or 19.2cm, respectively. Subjected to normal compression with load applied continuously and increasing until rupture, the specimens for the sleeve tests were made up of two old concrete specimens, with a 2cm layer of polystyrene between them – simulating the localized loss of resistant capacity of the structural element – coated with a sleeve made of grout (Figure 10 and Figure 11). At rupture, the value of the load reached was recorded.

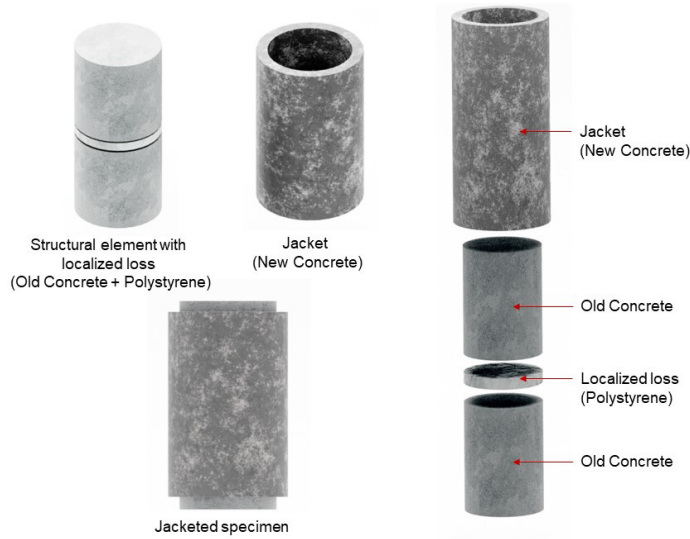
Figure 11. Schematic drawing of the sleeve test specimen elements

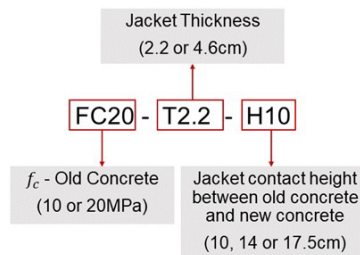
Figure 12. Identification code of the specimens of each series

As a way of better identifying the characteristics of the specimens analyzed in each series, a standard nomenclature was adopted as shown in Figure 12.

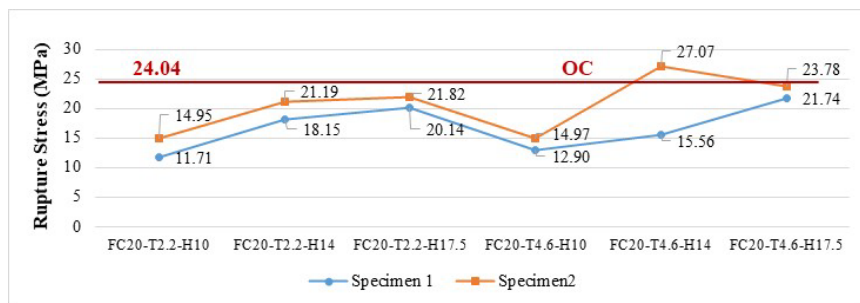
Figure 13. Series 1 – Rupture stress in the sleeve test

In Table 1 to Table 6, the average values obtained in the characterization tests of the old (OC) and new (NC) concrete in each series are presented, while, in Figure 13 to Figure 18, the compressive strengths obtained with each prototype of the sleeve test in each series are presented, in comparison to the respective compressive strength of old concrete (OC).

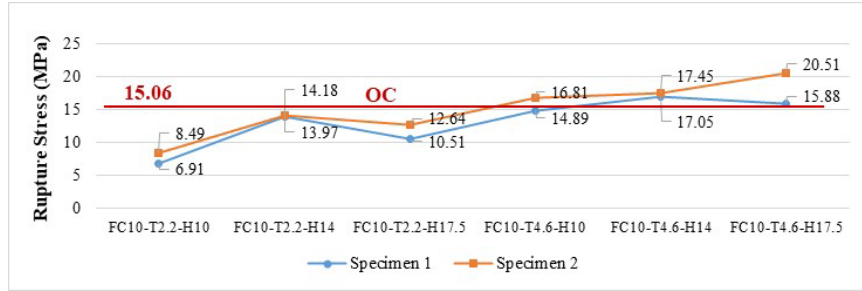
**Figure 14.** Series 2 – Rupture stress in the sleeve test

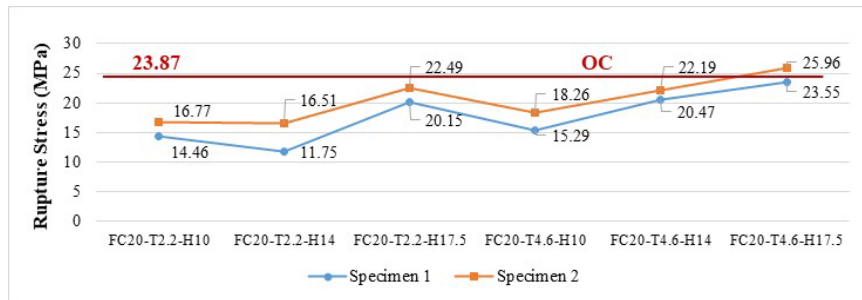
**Figure 15.** Series 3 – Rupture stress in the sleeve test

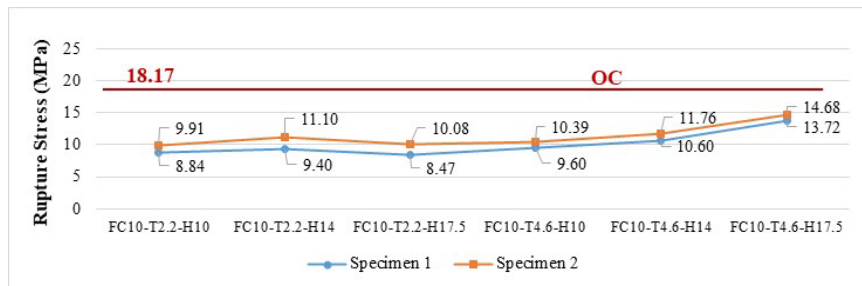
**Figure 16.** Series 4 – Rupture stress in the sleeve test

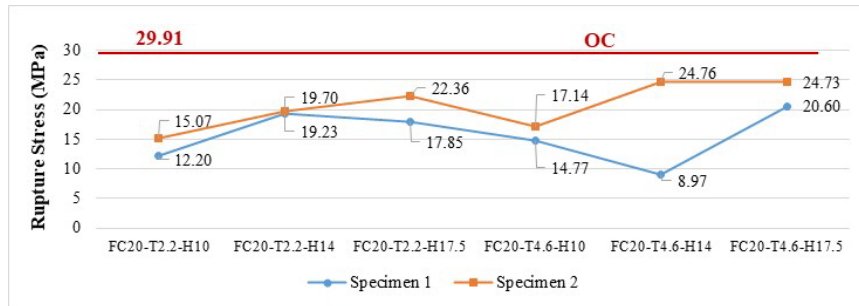
**Figure 17.** Series 5 – Rupture stress in the sleeve test

- In Series 5, for the case of jacket height of 14cm, the value of the coefficient of friction showed a negative sign, which has no physical sense. From Figure 17, it is observed that this anomaly is a consequence of the poor response obtained with one of the sleeve test specimens that presented an unexpected behavior whose cause was not identified.

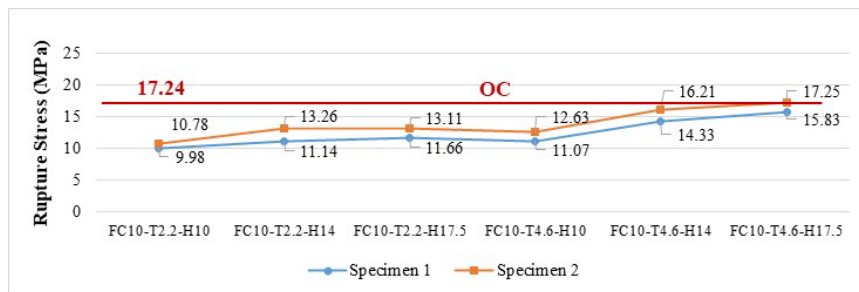
**Figure 18.** Series 6 – Rupture stress in the sleeve test

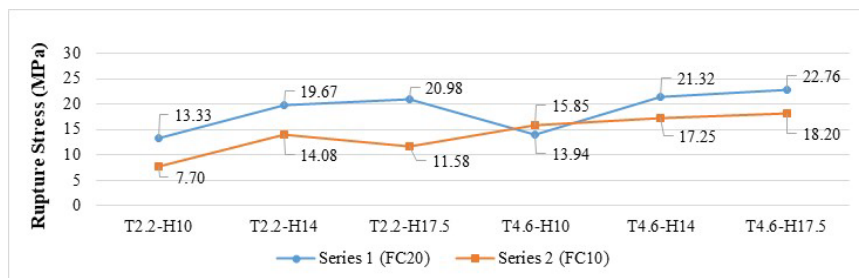
**Figure 19.** Series 1 x Series 2 – Average rupture stress in the sleeve test

In Figure 19, the average compressive strength values obtained in the sleeve test in Series 1 and Series 2 are compared, both series with epoxy adhesive surface treatment, being, respectively,  $f_c = 20\text{MPa}$  and  $f_c = 10\text{MPa}$ .

- For the case of jacket thickness of 2.2cm, a greater disparity is observed between the restored resistant capacities as a function of the strength to be restored (on average, 65%), compared to the case of jacket thickness of 4.6cm (in average, 12%).

- In both strengths to be restored, a greater gain in the restored resistant capacity is observed when the jacket height is increased from 10cm to 14cm, than when this height is increased from 14cm to 17.5cm.

- The responses obtained with  $f_c = 20\text{MPa}$  were monotonic with increasing thickness ( $t = 2.2$  to 4.6cm) and height ( $H = 10, 14$  to 17.5cm) of the jacket, which was not observed for the case of  $f_c = 10\text{MPa}$  with a jacket thickness of 2.2cm.

- From the standpoint of the idealized resistant capacity to be restored, it can be concluded that the thickness of the jacket of 2.2cm is sufficiently satisfactory when combined with heights of 14cm or 17.5cm for  $f_c = 10\text{MPa}$ , being the combination of jacket thickness of 4.6cm with heights of 14cm or 17.5cm recommended when dealing with  $f_c = 20\text{MPa}$ .

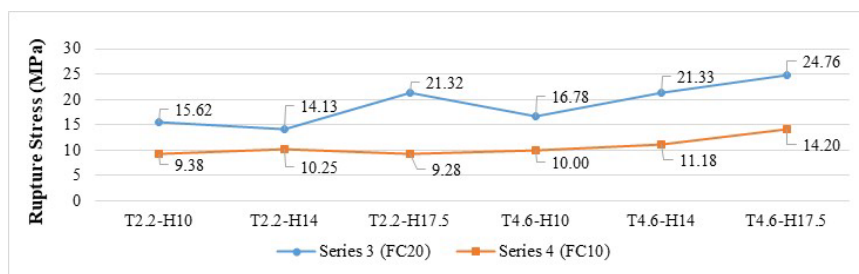
Figure 20. Series 3 x Series 4 – Average rupture stress in the sleeve test

In Figure 20, the average compressive strength values obtained in the sleeve test in Series 3 and Series 4 are compared, both series with holes with drill surface treatment, being, respectively,  $f_c = 20\text{MPa}$  and  $f_c = 10\text{MPa}$ .

- In average values, for both jacket thicknesses, an equal disparity is observed between the restored resistant capacities as a function of the strength to be restored, that is, for  $t = 2.2\text{cm}$  and  $t = 4.6\text{cm}$ : 78%.

- In the strength to be restored of 10MPa, for the case of a jacket thickness of 2.2cm, no gain in the restored resistant capacity with an increase in the jacket height is observed, whereas, for the case of a jacket thickness of 4.6cm, there is a greater gain in the restored resistant capacity when the jacket height is increased from 14cm to 17.5cm than when this height is increased from 10cm to 14cm. In the strength to be restored of 20MPa, for the case of a jacket thickness of 2.2cm, a greater gain in the restored resistant capacity is observed when the jacket height is increased from 14cm to 17.5cm, than when this height is increased from 10cm to 14cm (in fact, a slight reduction is observed), whereas, in the case of a jacket thickness of 4.6cm, the opposite is observed, that is, a greater gain in the restored resistant capacity when the jacket height is increased from 10cm to 14cm, than when this height is increased from 14cm to 17.5cm, although a gain is also observed.

- From the standpoint of the idealized resistant capacity to be restored, it can be concluded that a jacket thickness of 4.6cm is recommended for both strengths combined with heights of 14cm or 17.5cm.

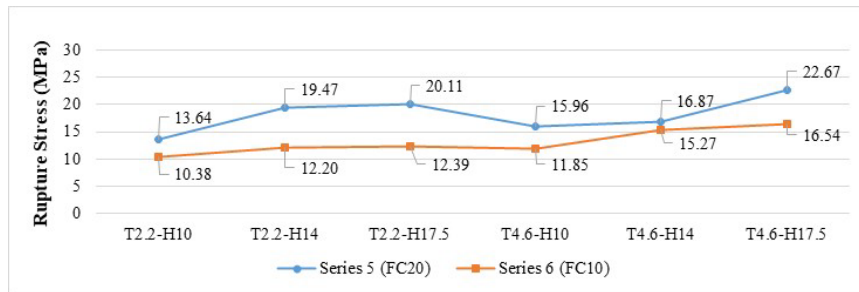
Figure 21. Series 5 x Series 6 – Average rupture stress in the sleeve test

In Figure 21, the average compressive strength values obtained in the sleeve test in Series 5 and Series 6 are compared, both series with sanding surface treatment, being, respectively,  $f_c = 20\text{MPa}$  and  $f_c = 10\text{MPa}$ .

- For the case of jacket thickness of 2.2cm, a greater disparity is observed between the restored resistant capacities as a function of the strength to be restored (in average values, 51%), compared to the case of jacket thickness of 4.6cm (in average values, 27%).

- In both strengths to be restored, except for the case of  $f_c = 20\text{MPa}$  and jacket thickness of 4.6cm, a greater gain in the restored resistant capacity is observed when the jacket height is increased from 10cm to 14cm, than when this height is increased from 14cm to 17.5cm.

- The responses obtained with  $f_c = 10\text{MPa}$  were monotonic with increasing thickness ( $t = 2.2$  to 4.6cm) and height ( $H = 10, 14$  to 17.5cm) of the jacket, which was not observed for the case of  $f_c = 20\text{MPa}$  with a jacket height of 14cm.

- From the standpoint of the idealized resistant capacity to be restored, it can be concluded that the jacket thickness of 2.2cm is sufficiently satisfactory, combined with any of the three heights considered, in the case of  $f_c = 10\text{MPa}$ . For the case of  $f_c = 20\text{MPa}$ , the combination of jacket thickness of 4.6cm with a height of 17.5cm is recommended.

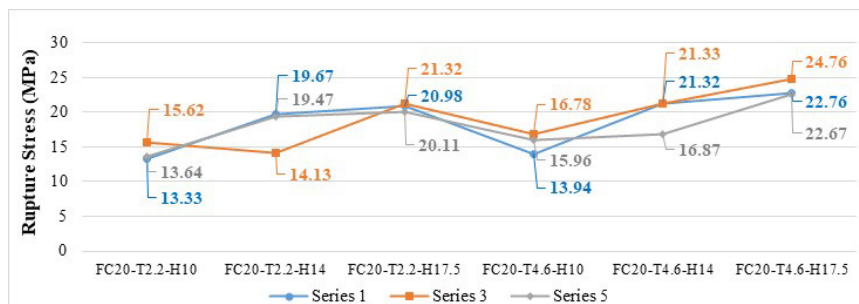
Figure 22. Series 1 x Series 3 x Series 5 – Average rupture stress in the sleeve test

In Figure 22, the average compressive strength values obtained in the sleeve test in Series 1, Series 3, and Series 5 are compared, all with  $f_c = 20\text{MPa}$ , with surface treatment, respectively, of the epoxy adhesive type, holes with drill and sanding.

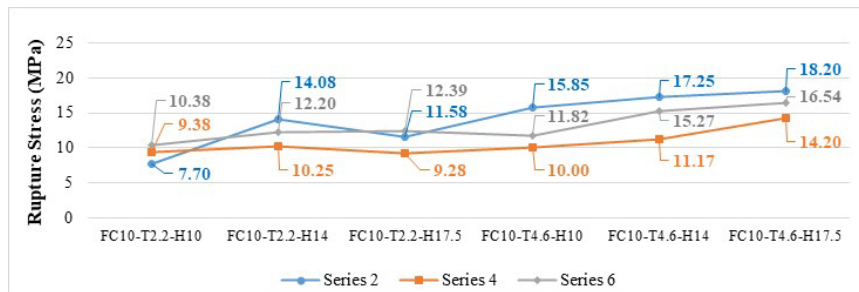
Figure 23. Series 2 x Series 4 x Series 6 – Average rupture stress in the sleeve test

In Figure 23, the average compressive strength values obtained in the sleeve test in Series 2, Series 4, and Series 6 are compared, all with  $f_c = 10\text{MPa}$ , with surface treatment, respectively, of the epoxy adhesive type, holes with drill and sanding.

- Except for the case of jacket thickness of 2.2cm combined with a height of 10cm, the holes with drill surface treatment showed the worst restored strength capacity responses, the opposite of what was observed in the case of  $f_c = 20\text{MPa}$ .

- It can be concluded that, for the case of an idealized strength capacity to be restored of 10MPa, the thickness of 2.2cm combined with any of the three heights is sufficiently satisfactory when using sanding surface treatment or combined with heights of 14cm or 17.5cm when using epoxy adhesive surface treatment. In the case of holes with drill surface treatment, it is recommended to use a thickness of 4.6 cm.

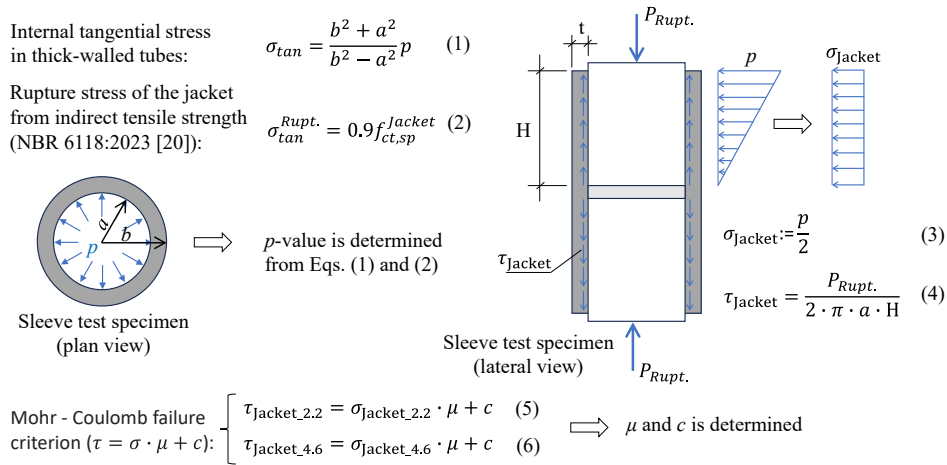
**Figure 24.** Methodology for calculating the coefficient of friction ( $\mu$ ) and adhesion ( $c$ ) based on NBR 6118:2023[20]

Piancastelli [1], based on the analysis of fundamental concepts of mechanics of material, equated a linear system through which it is possible to obtain the values of the coefficient of friction and adhesion from the results obtained in the sleeve test, as illustrated in Figure 24.

The validity of the methodology presented in Figure 24 is based on the predominant rupture mode observed in the sleeve tests, illustrated in Figure 25 to Figure 28, in which it is observed that the rupture of the specimen begins with the appearance of longitudinal cracks in the repair jacket (new concrete), resulting from the tangential tensile stress to which it is subjected, with subsequent separation of the core (old concrete) and the jacket, that is, the typical failure mode of confined columns. Similar failure modes were observed in experimental studies by Piancastelli [1] and Enami [3].

Following the linear system equated in Figure 24, the coefficient of friction and adhesion calculations were performed for each series according to the Table 7 to Table 12.

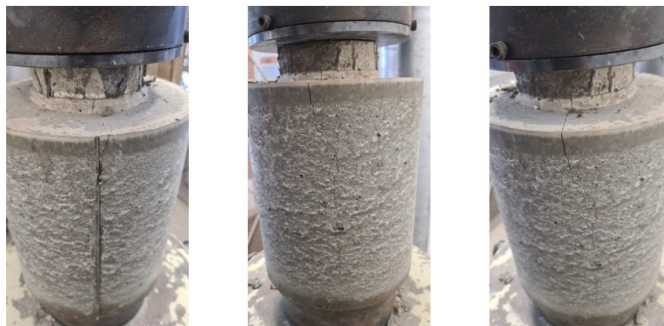
**Figure 25.** Longitudinal crack in a specimen with  $t = 4.6\text{cm} / H = 10\text{cm}$

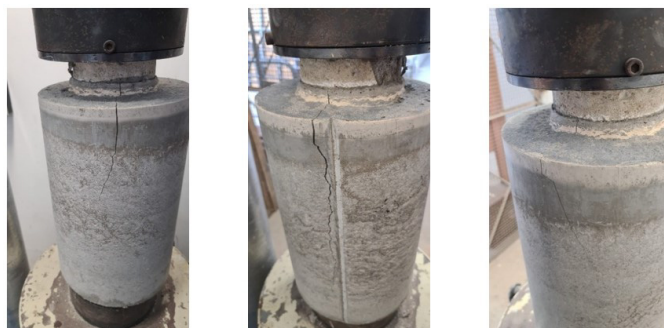
**Figure 26.** Longitudinal crack in a specimen with  $t = 4.6\text{cm} / H = 14\text{cm}$

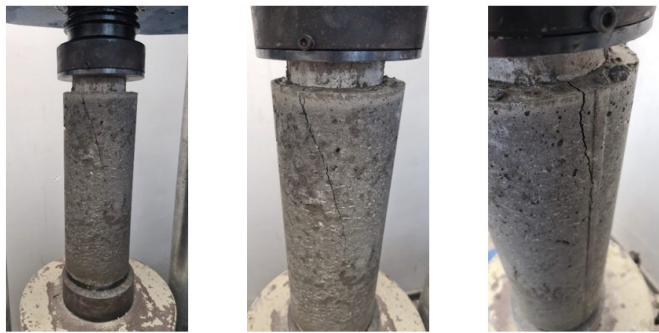
Figure 27. Longitudinal crack in a specimen with  $t = 2.2\text{cm} / H = 17.5\text{cm}$

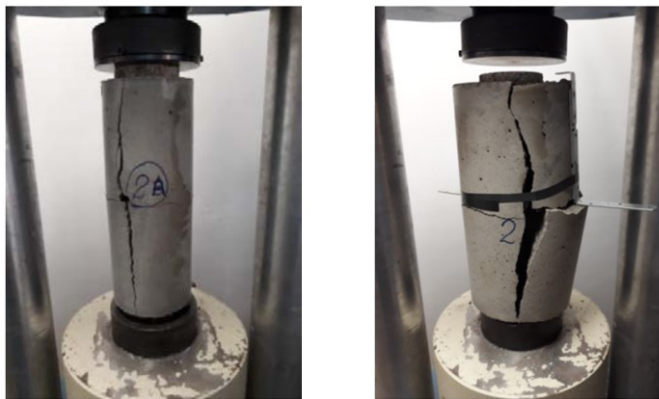
Figure 28. Separation of the core (old concrete) and the jacket (new concrete)
